# Technical Service Bulletin

## 91 SOS Warning displayed in the instrument cluster, no communication to the telematics control module

91 20 77 2056076/8 June 12, 2020. Supersedes Technical Service Bulletin Group 91 number 20-40 dated February 21, 2020 for reasons listed below.

Model(s)	Year	VIN Range	Vehicle-Specific Equipment
A4, A5	2019	All	With ConBox
A6, A7, A8, Q5, Q7, Q8, and Audi e-tron quattro	2019 - 2020	All	With ConBox

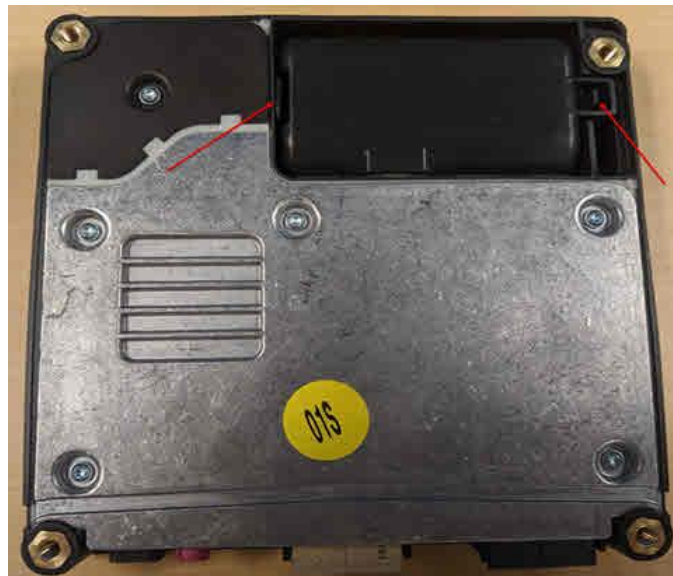
**Figure 2.** Backup battery compartment location.

1. Remove and unplug the telematics control module, J949 (address word 0075) according to the repair manual in Elsa.
2. Open the battery compartment of the telematics control module, J949 (address word 0075) and disconnect the backup battery (Figures 2 - 3).

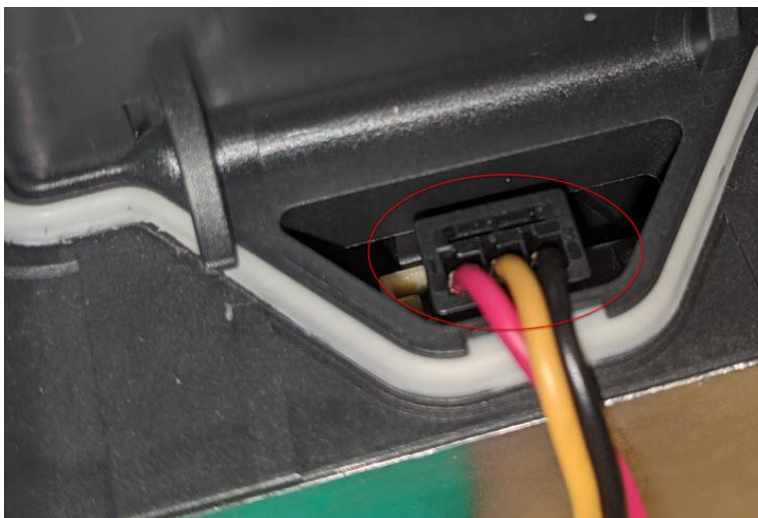
**Figure 3.** Backup battery connector (no release mechanism).

3. Leave the battery disconnected for approximately 60 seconds.
4. Reinstall the backup battery back into the telematics control module, J949 (address word 0075).
5. Reinstall the telematics control module, J949 (address word 0075) back into the vehicle.
6. **If ODIS still cannot connect** to the telematics control module, J949 (address word 0075), follow the ODIS test plan.
